Spectra TFinity Library

Release Notes and Documentation Updates

90940044 Revision X

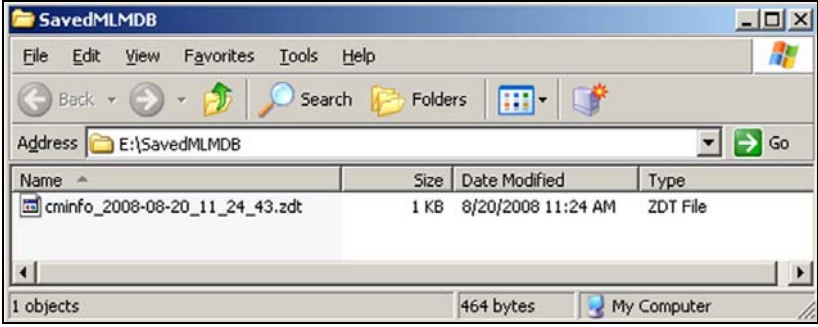
<p>Note: In this example, the file is called T950_SF2.bsk. The screen shown here also includes the SavedMLMDB and SavedConfigs folders.</p>
<p>MLM and DLM Data</p>

<p>Note: In this example the file has a .zdt extension. The file will be named xmlinfo<date-time>.db if you did not choose to zip the file when you created it.</p>
<p>Configuration data</p>

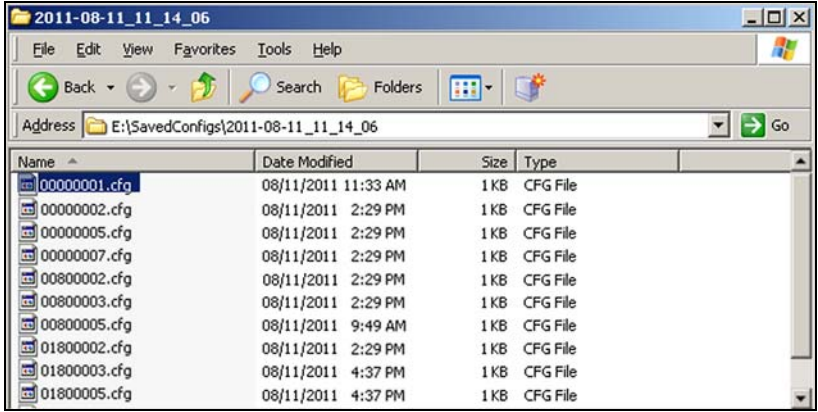
<p>Note: The files are located in the \SavedConfigs\<<date-time> folder, where <date-time> in this example is 2011-08-11_11_14_06.</p>
