Spectra T120 Library

Release Notes and Documentation Updates

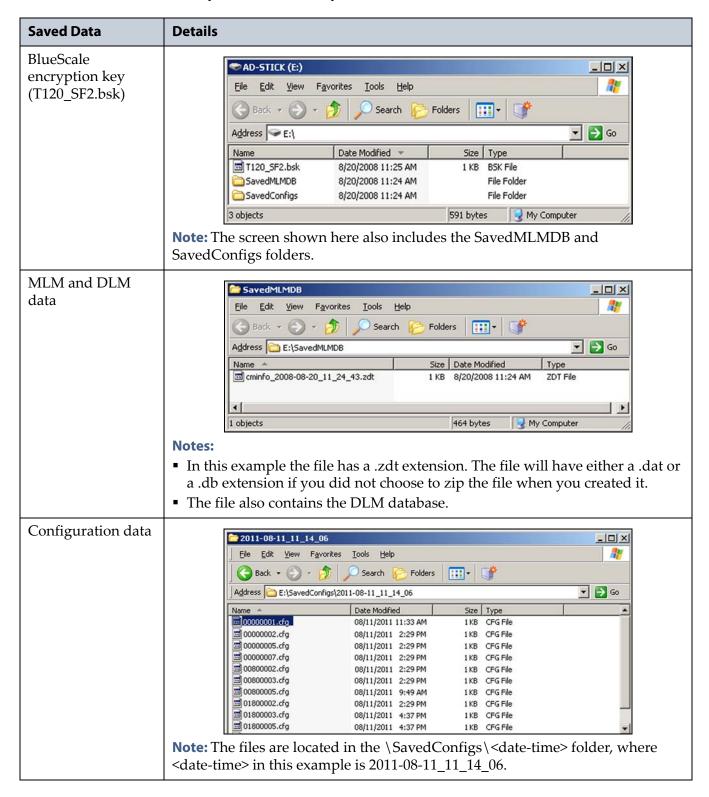
Examples of Saved Configuration Files

The following figures show examples of the files that display when you check your USB memory device/email.
