# Spectra T950 Library

## Release Notes and Documentation Updates

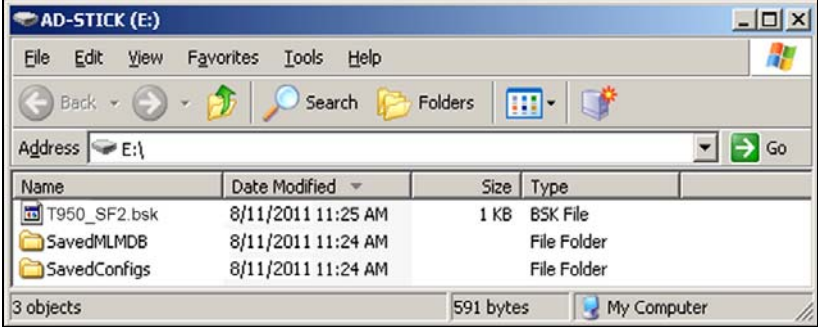
The following figures show examples of the files that display when you check your USB memory device/email.

Saved Data	Details
<p>BlueScale encryption key (T950_SF2.bsk)</p>

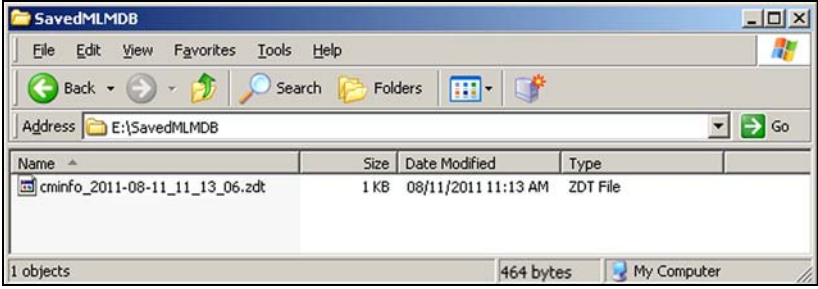
<p><b>Note:</b> The screen shown here also includes the SavedMLMDB and SavedConfigs folders.</p>
<p>MLM and DLM data</p>

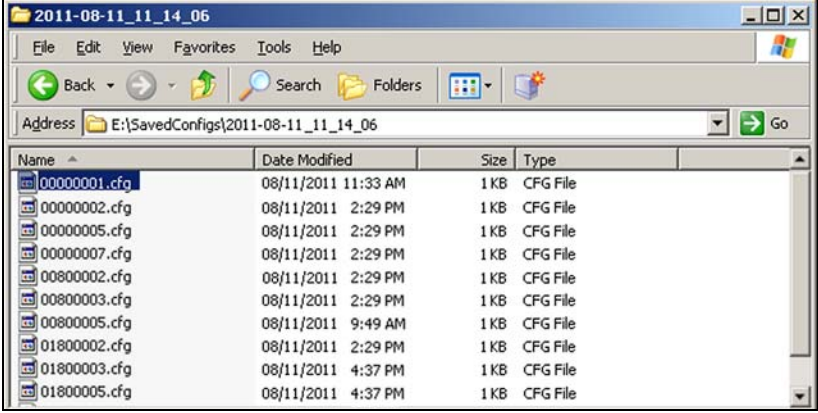
<p><b>Notes:</b></p> <ul style="list-style-type: none"> <li>▪ In this example the file has a .zdt extension. The file will have either a .dat or a .db extension if you did not choose to zip the file when you created it.</li> <li>▪ The file also contains the DLM database.</li> </ul>
<p>Configuration data</p>

<p><b>Note:</b> The files are located in the \SavedConfigs\&lt;&gt;date-time&lt;&gt; folder, where &lt;date-time&gt; in this example is 2011-08-11_11_14_06.</p>
